Proposal for environmental recovery in drainage bedside of Tamanduazinho River, Foz do Iguaçu, Parana

Ana C. Cabral *, Elisandro P. Frigo, Angelo G. Mari, Alvaro Mari Junior, Abílio L. Colognese, Helton J. Alves and Samuel N. M. de Souza

University of Western Paraná (UNIOESTE), Cascavel, Jd. Universitário, 2069, Paraná, Brasil.

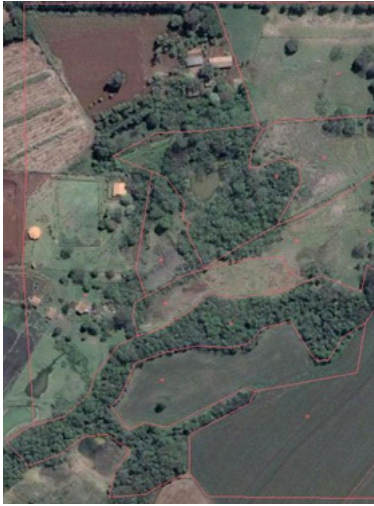
Figure 1. Landscape definition in the studied area.
Source: Adapted from GOOGLE EARTH, 2008.

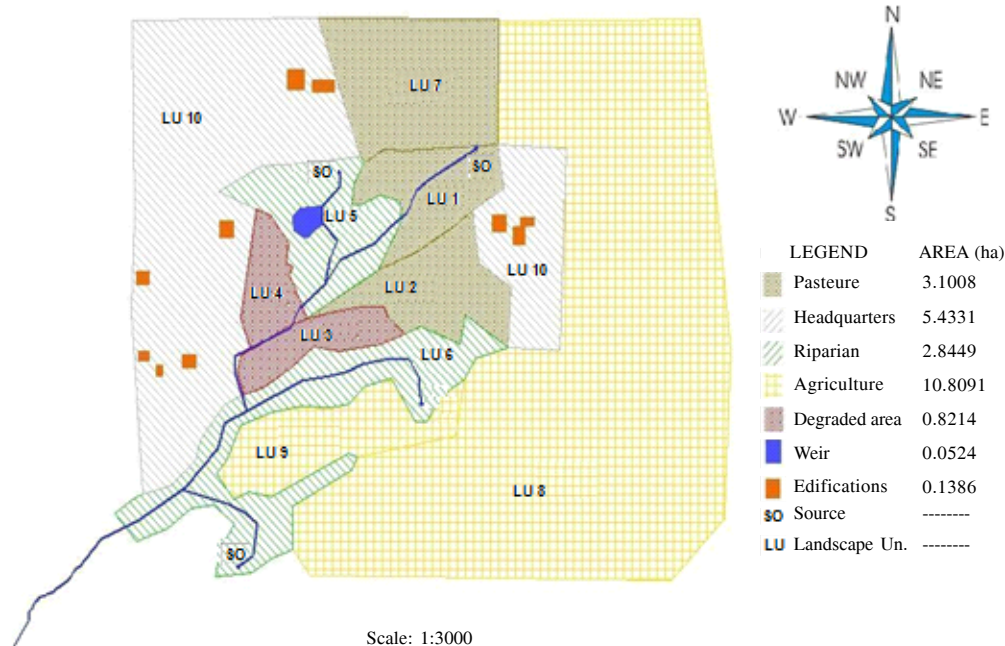
Landscape unit 1: The main source of Tamanduazinho River is an initial accumulation, a floodplain covered by grasses. There is not any ciliary forest on the source, and the area is used as pasture for

the small flock of a rural property. According to the classification⁷, this landscape unit has environmental risk CLASS V - PR 5, RE 1, RI 5, HI 5, DR 5, i.e., lands with very high environmental risk class, mainly due to the presence of surface gleization and the high risk of flooding. The use of this area as pasture can seriously compromise the soil² and water quality of Tamanduazinho River by promoting erosion and eutrophication from the source of this body of water.

Landscape unit 2: This area lies between sources of Tamanduazinho River, but does not present surface gleization. This is a degraded pasture with slightly compacted soils, mainly due to overgrazing in loamy and moist soil.

The soil risk in this landscape unit is CLASS III - PR 2, RE 2, RI 3, DR 3, i.e., a soil with poor drainage and very prone to flood.

Landscape unit 3: This landscape unit represents the most degraded area covered by this study. Due to mining⁴, the lack of forest cover and erosion, large gully erosions were formed in this shallow area covered by thinned grassland soil.

The soil of this landscape unit is considered CLASS V - PR 4, RE 2, RI 4, HI 4, DR 4, i.e., shallow soil, with an accentuated presence of hydromorphism, risk of severe flooding and insufficient drainage.

Landscape unit 4: This is part of the headquarters area of a property, but soil is very degraded by mining and erosion by splash erosion, which did not allow the establishment of vegetation. This area soils have risk CLASS IV - PR 3, RE 2, RI 4, HI 3, DR 3, because of the high risk of flooding and hydromorphism.

Figure 2. Diagnosed landscape units and their land use.

Landscape unit 1: Construction of a smooth wire fence is proposed, with six wires around the source at a distance of 50 m, and along the river, at a distance of 30 m, as recommended ¹.

Landscape unit 2: The compaction and lack of forest coverage at this LU favour the surface flooding, and consequently aggravates erosion by the LU3 gully erosion, which is downstream. It is suggested that this area becomes part of the legal reserve of the rural property as established ¹. To do so will be necessary that the soil undergoes a subsoiling to break up the compacted layer, and then be replanted with native species.

Landscape unit 3: It is suggested the gullies recovering, requiring the area to be fenced and that the surface flooding from the LU 2 is stopped before entering the headboard of the gully, through the construction of temporary drains upstream of this degraded

area. Since it is furrows with less than 1 m deep, the technique of filling the gullies with branches and trunks arranged in its riverbed to serve as a restraint for surface flooding and sediment can be adopted ⁶.

Landscape unit 4: This area needs to be fenced to prevent vehicular and domestic animal traffic, and should use mulch to dampen the impact of rain drops that cause erosion. The decomposed organic matter helps in the formation of a layer of fertile earth, suitable for revegetation of the area. Given its proximity to the LU 5 and 6, the isolation and abandonment of the area associated with the use of mulch is sufficient for regeneration of the vegetation in this landscape unit.

Landscape unit 5: It is proposed that an area equivalent to 50 m around the source and 30 m around the pond be fenced and abandoned for natural regeneration. This corresponds to a decrease of headquarters and pasture areas, but no building is within the area to be fenced, which prevents larger socio-economic losses.

Landscape unit 6: The vegetation is also at an advanced stage of regeneration and, as in landscape unit 5, the width of the preserved area does not match the recommended by the environmental legislation. Thus, it is proposed the implantation of fences at 30 m along the river banks, and at 50 m around the sources in the area. This fenced area can be abandoned for natural regeneration, for it does not imply higher risks for the environment.

Landscape unit 7: This landscape unit must be surrounded with wire fences of six smooth wire in order to prevent the entry of cattle, and abandoned to natural regeneration.

Landscape unit 8 – Preserved agriculture: The agriculture developed in this area already has some conservation practices such as crop rotation, direct planting and terracing, not requiring measures for environmental restoration of the area, except at the points where the crops overlay areas which should be of permanent preservation. In these areas, the land should be abandoned, in order to establish native vegetation and become a part of the forest represented by LU 6.

Landscape unit 9: The ideal use for this landscape unit is the establishment of native forest coverage that becomes part of the Legal Reserve of the property.
